# **A New Survey of the Stone Stiles of Cam in November 2020 to April 2021**

**By John Fowles**

This new survey was carried out in November 2020 to April 2021 to update and supplement the previous survey. In the meantime an additional stone stile has been found in the Jubilee Field (a Parish Council owned leisure area) and that has been included in this new survey as SS16. Some of the stile numbers have been changed slightly as described in the text.

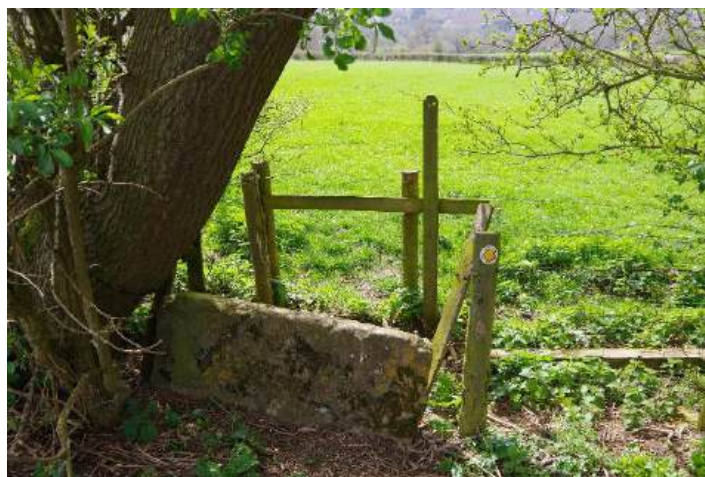
SS1A

**SS1A** is on CCA63 and is in good condition. It is leaning slightly and the adjacent wooden stile has been removed since 2007. It could be raised to the vertical but it is probably not worth the effort. There is a tree leaning across it and the nearby additional wooden stile ( see picture) does not have a step making it difficult to cross (it has a wire mesh within the frame). The 1A marker has been attached to the adjacent post.

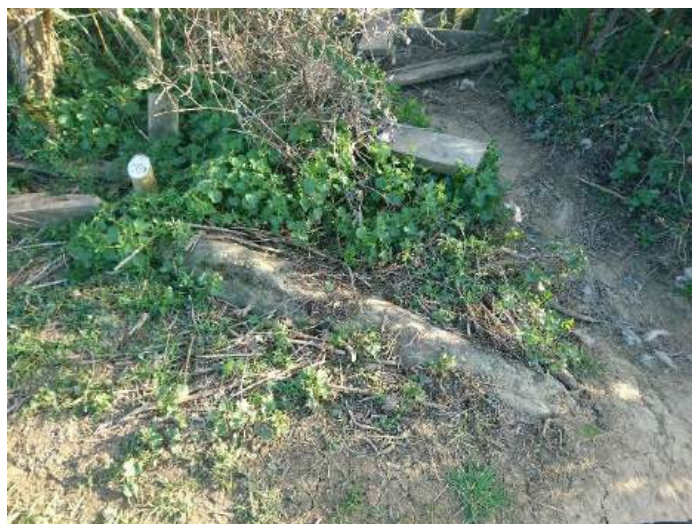
**SS1B** is on CCA60 and is very low. It is probably a complete stile leaning forward and sunk deep into the ground. The accompanying wooden stile has rotted and has been removed to the hedge nearby since 2007. SS1B is worn where walkers used to step onto it after crossing the wooden stile but they can now walk round it. With considerable effort it could be excavated and raised to the vertical. SS1B marker has been attached to a new post close to the hedge.

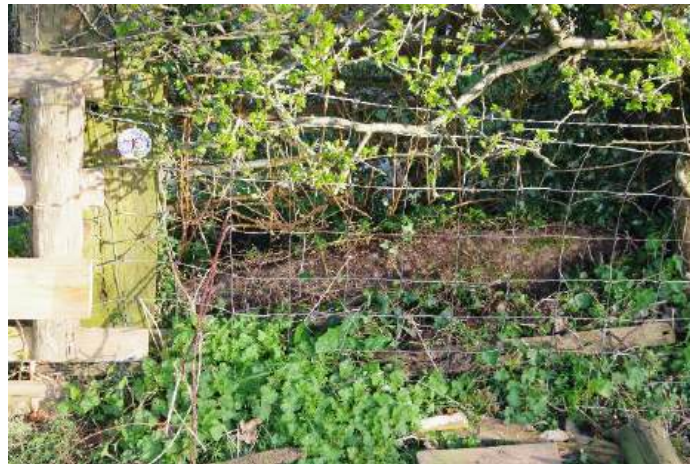
**SS1C** is also on CCA60 by a wooden stile. It is immediately to the west of SS1B. It is deep within the hedge and covered in moss and grass making it difficult to spot. There is also an old iron gate leaning on one side of it. The removal of the grass and other plants to make it more visible would be beneficial. A lot of the ivy has been removed from one side. The SS1C marker has been placed on the wooden post to the left of the picture.

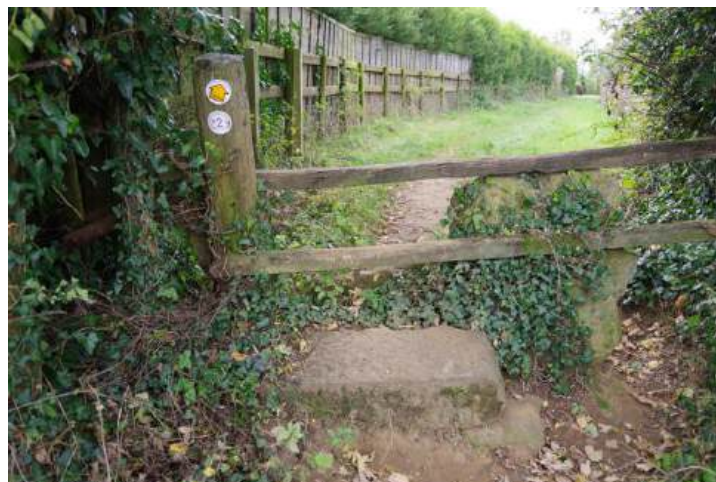
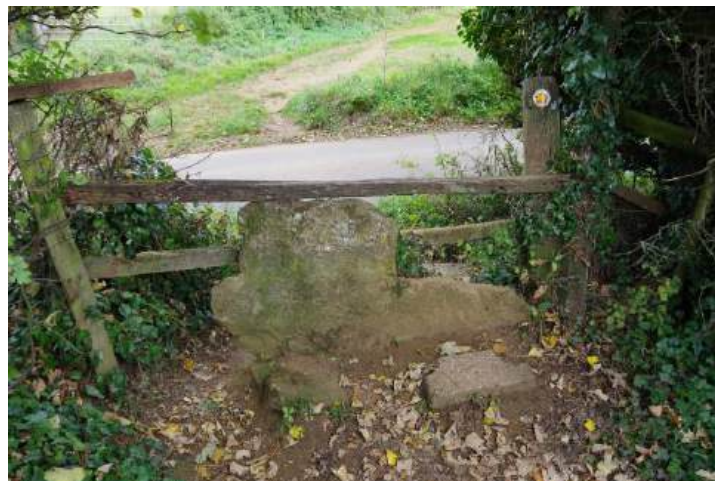
**Stone Stile 2** SS2 is a single stile to the west of Field Lane at the start of paths CCA13 and CCA14 - map reference 738004 (Longitude 51.7016, Latitude -2.3803) near to the mobile phone mast. CCA14 has been diverted by the creation of a large fence and fast-growing, coniferous hedge. The stone is broken but the larger section is upright and supported and protected by the wooden stile. No work is required on this stile. SS2 marker has been attached to the wooden stile.

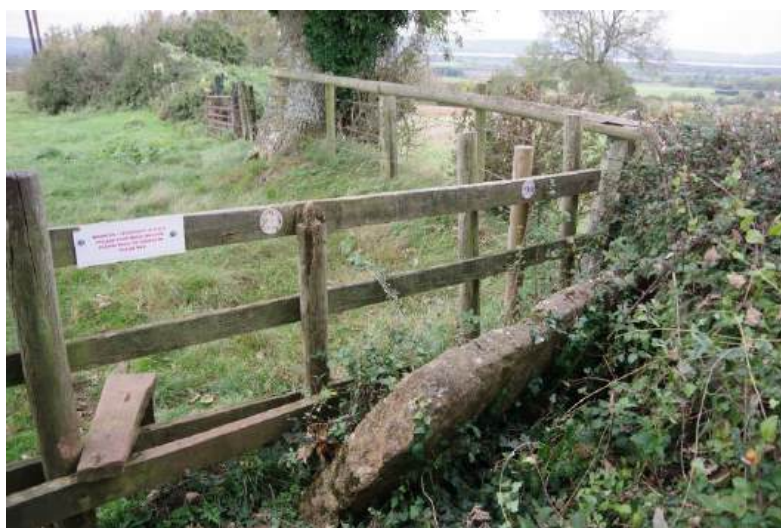
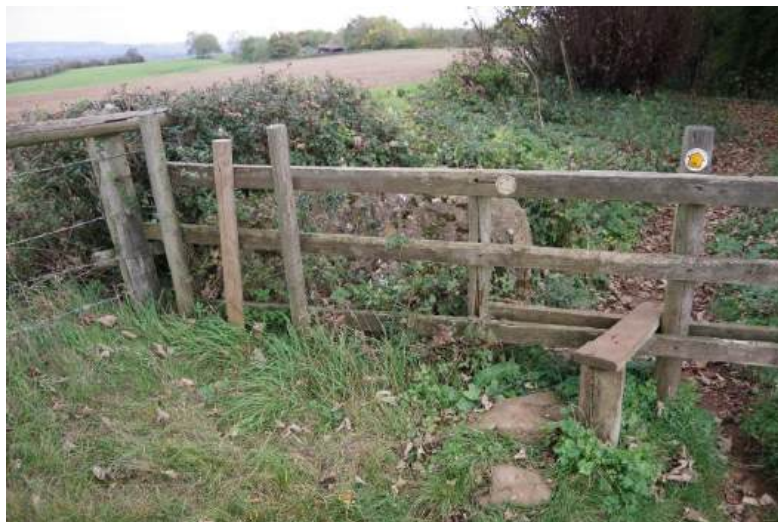
**Stone Stile 3A** SS3A was referred to as SS3 in the 2007 report. It is a single stile beyond an excavated area on CCA13, the same path as SS2. It is at map reference 734004 (Longitude 51.7018, Latitude -2.3833). It is leaning slightly away from the wooden stile and is supported by a small earth bank covered in vegetation which grows across the stone in summer. The stone could be raised to the vertical and supported on the earth bank side by a protective wooden frame. The dense vegetation could be removed from the earth bank making it more visible. SS3A marker has been attached to the wooden stile.

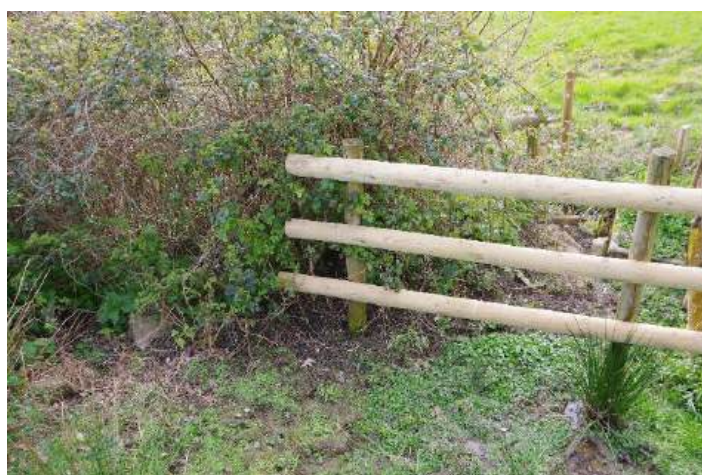
SS3B

**Stone Stile 3B** This was stile 3A in the 2007 report. It is at map reference 734003 (Longitude 51.7011, Latitude -2.3860) next to a spring that fed a trough in 2007. The area is in the same field as SS3A above but in another hedge about a hundred metres to the south and on the route of footpath, CCA107. The bulk of the stone and the trough have been removed since 2007 and a pile of stones at the bottom of the field, next to a gate, is probably it. It was a few metres downhill from a wooden stile but that stile has been replaced by a fence and barbed wire. The area is virtually impassable anyway because the spring that fed the trough now creates a large marshy area and so walkers have had to divert the path to use the gate mentioned above.

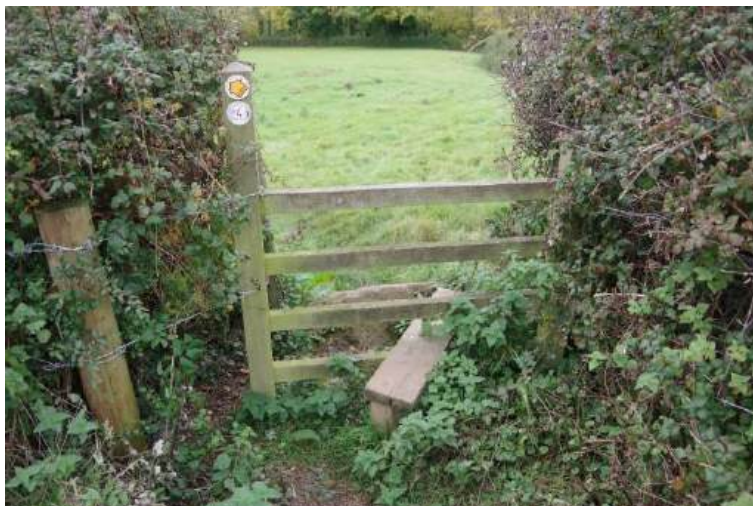
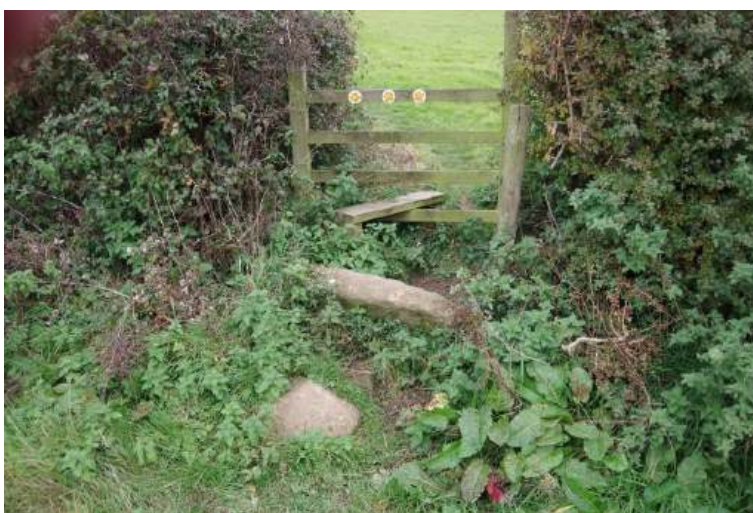
**Stone Stile 4** SS4 is a single stile on CCA13/CCA107 at map reference 733004 (Longitude 51.7016, Latitude -2.3880). It is leaning away from the wooden stile and appears to have a piece broken off and lying nearby. The stone could be raised to vertical, incorporating the broken bit if appropriate, and joined into the wooden stile. This would require considerable effort and the rebuilding of the wooden stile which is in good condition. Marker SS4 has been attached to the wooden stile.

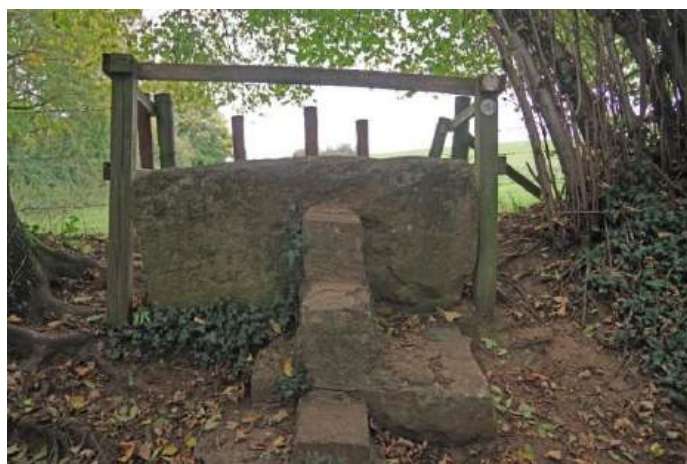
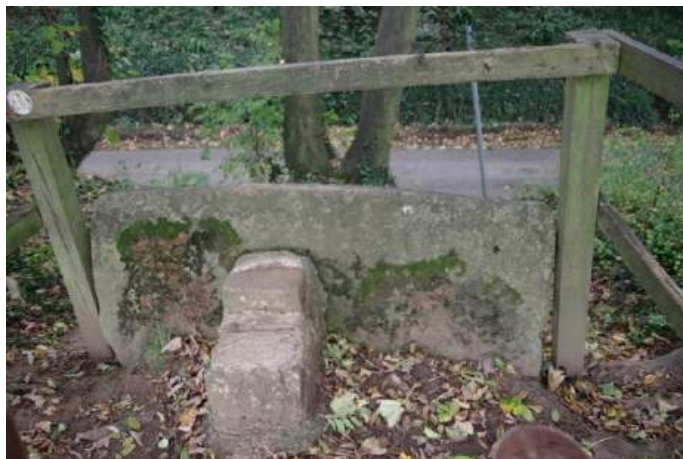
**Stone Stile 5** SS5 is at the top of a bank on the east side of Field Lane on CCA20 at map reference 737007 (Longitude 51.7044, Latitude -2.3209). It is upright, incorporated into a wooden stile and supported on each side by concrete steps. SS5 marker has been attached to the wooden stile.

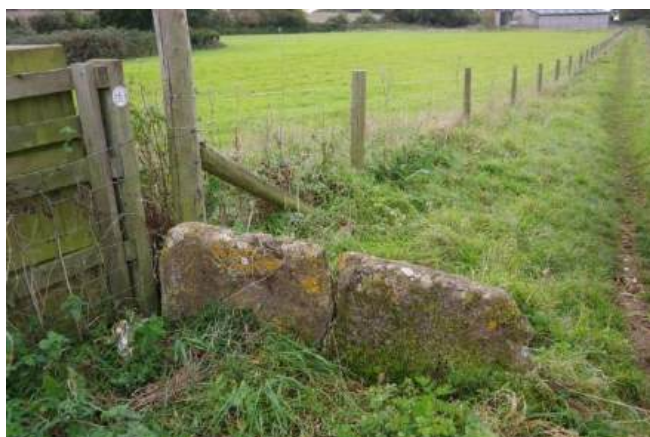
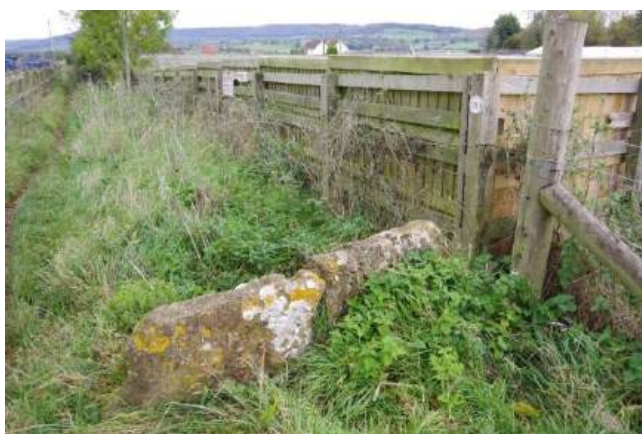
**Stone Stile 6** SS6 is on CCA40, at map reference 740004 (Longitude 51.7023 , Latitude -2.3771 ). It is broken in two and in 2007 one half was close to horizontal and the other half close to vertical. The horizontal part is now vertical close to its original position. The stone has no supporting frame and the boundary fence/hedge has been removed. SS6 marker has been attached to the fence post.

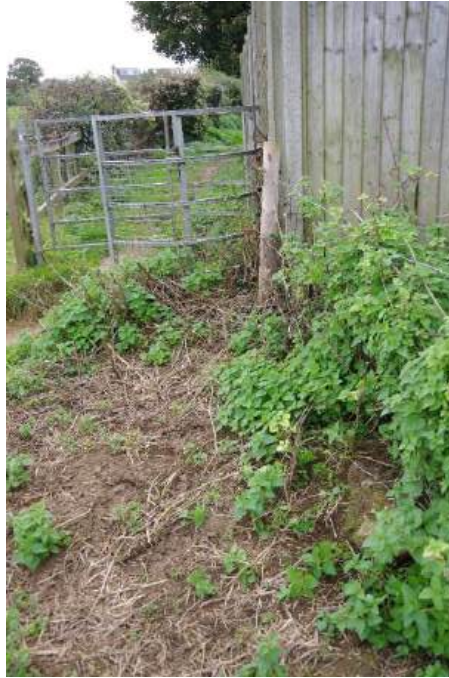
Site of SS7

**Stone Stile 7** This stile on CCA43 at map reference 742004 (Longitude 51.7019 , Latitude -2.3748) was destroyed in 2001 by workmen installing a kissing gate. A small remnant remains in the fence (bottom right of picture).

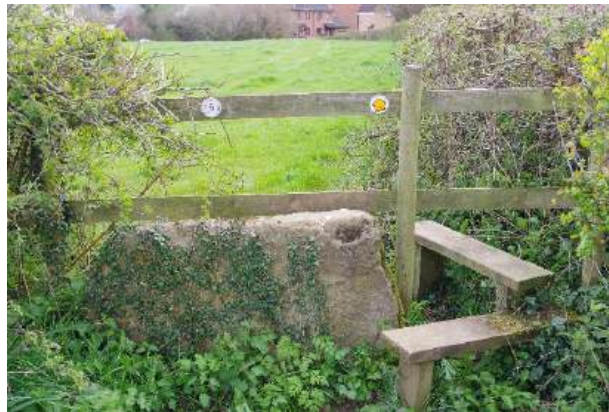
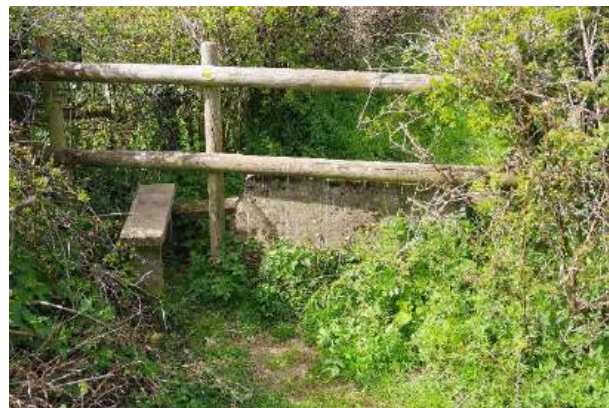
**Stone Stile 8** SS8 is near to the Jubilee Field at Draycott on CCA22 at map reference 745010 (Longitude 51.7074 , Latitude -2.3697). It now vertical within a wooden stile and appears to be complete. It has been marked as SS8 on the wooden stile.

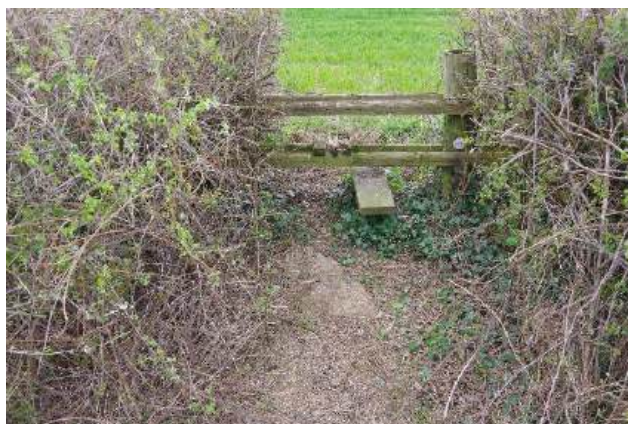
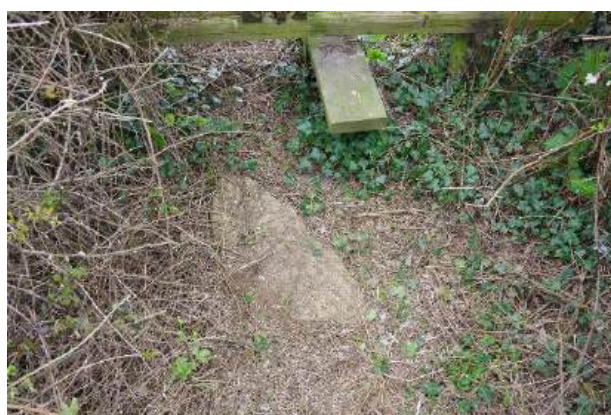
**Stone Stile 9** SS9 is a fragment of what could have been a stone stile lying next to a wooden stile on CCA24 at map reference 744015 (Longitude 51.7116 , Latitude -2.3707). It is

not obvious how it relates to an original stone stile. It is currently used as a stepping stone but could be secured within the existing wooden stile to protect it. It has been marked as SS9. This stile was heavily covered with brambles and hawthorn and that has now been removed to make the stile usable again. The SS9 marker has been attached to the wooden stile.

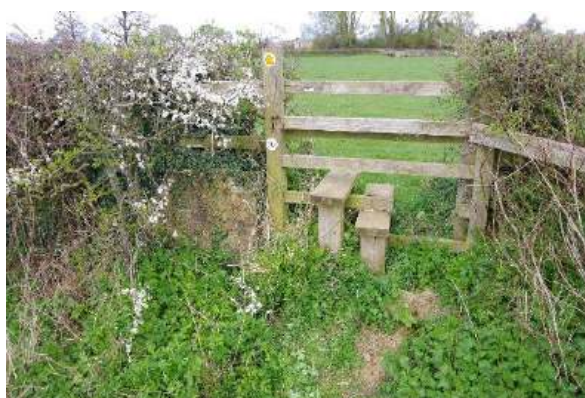
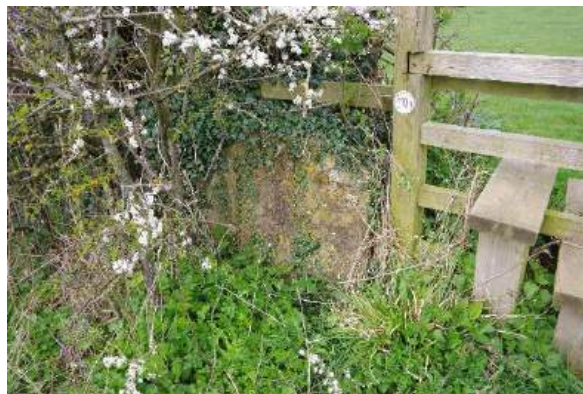
**Stone Stile 10** SS10 is close to SS9 on CCA24 at map reference 745015 (Longitude 51.7126 , Latitude -2.3693). It stands in the hedgerow next to a wooden stile and is close to vertical. The hedge could be cut back on one side to make it more visible. The SS10 marker has been attached to the wooden stile.

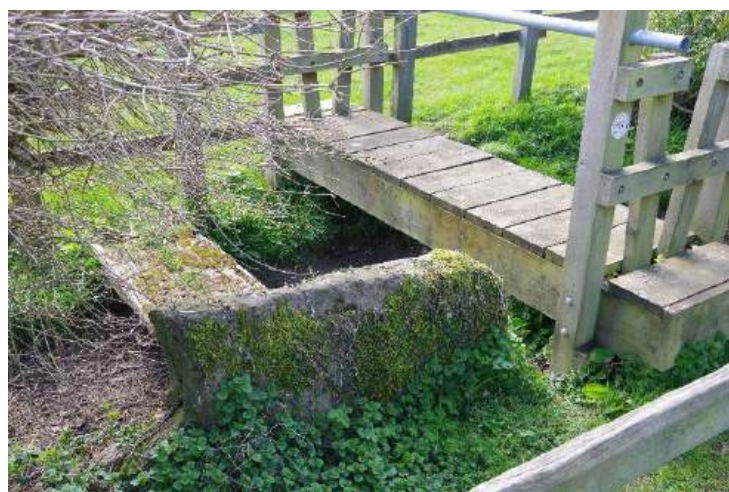
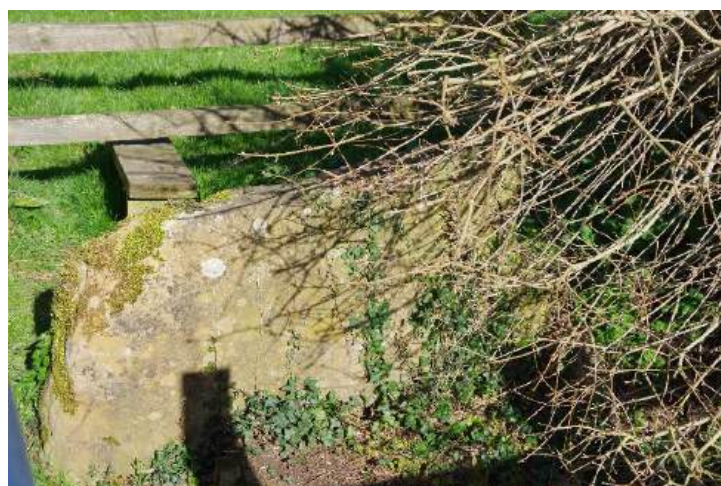
**Stone Stile 11** SS11 is in the same footpath as SS9 and SS10, CCA24, at map reference 746016 (Longitude 51.7130 , Latitude -2.3683). It stands vertically and requires no work doing to it. A new stile and bridge has been built next to it, bypassing the original stile and bridge over the ditch. It has been marked SS11 on the new stile.

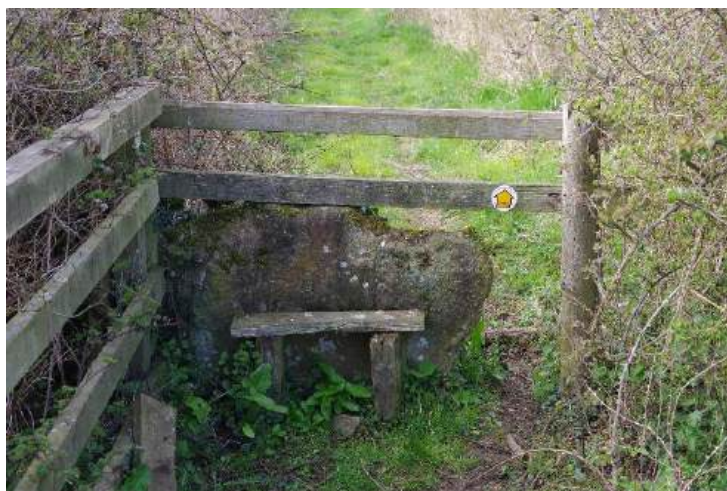
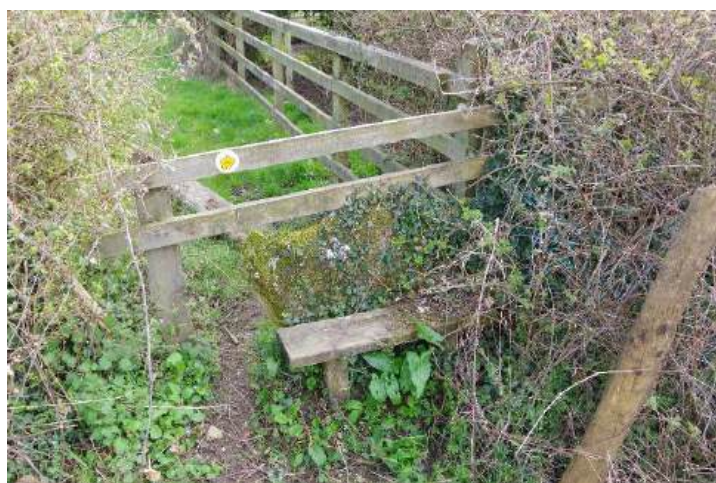
**Stone Stile 12** SS12 is just around the corner from SS11, but on CCA25, and at the same map reference 746016 (Longitude 51.7131 , Latitude -2.3682). It looks damaged but is vertical and well supported in a wooden stile. No work is required on it. It has been marked SS12.

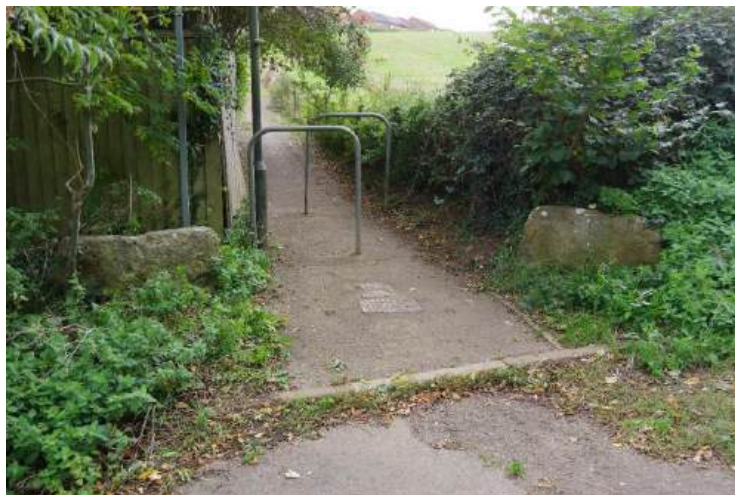
**Stone Stile 13** SS13 is the junction of Blind Lane, Elstub Lane and a footpath to Woodfield, CCA50. It is on the edge of the Bovis Estate at map reference 745002 (Longitude 51.7131 , Latitude -2.3682 ). The stone is in two halves and they have been positioned on either side of the start of the footpath to Woodfield. I am told that it was originally at a field boundary higher up this footpath (nearer to Woodfield). Given that the footpath has been converted to a 'snicket' or urban alley it is not clear how the stile could be replaced. It is probably best left where it is. It has been marked as SS13 on a new post.

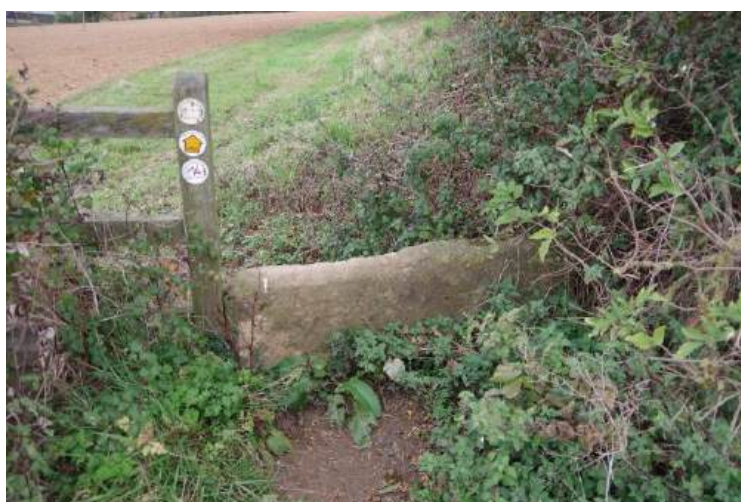
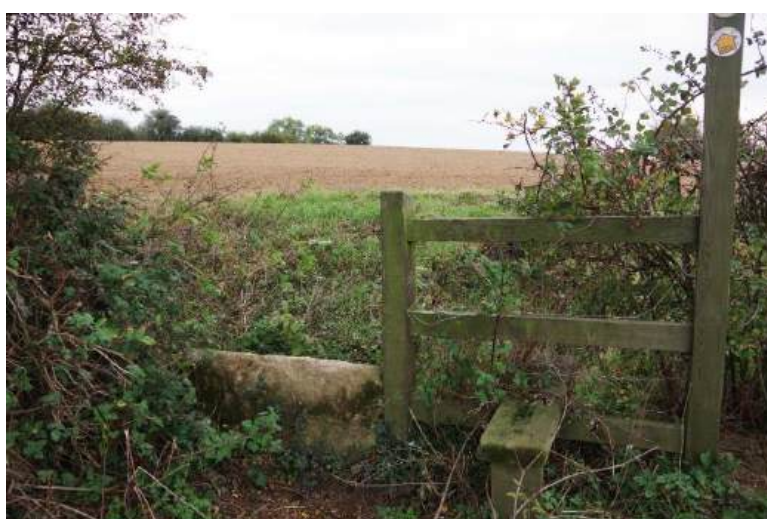
**Stone Stile 14** SS14 is on the path between SS4 and SS5, CCA12. It stands next to a wooden stile at map reference 735005 (Longitude 51.7031, Latitude -2.3849). It is close to vertical and the brambles have been removed. It is now used by walkers instead of the wooden stile. SS14 marker has been attached to the wooden stile.

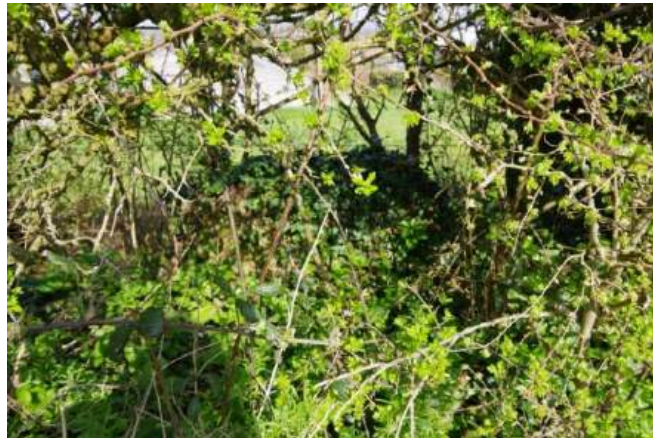
**Stone Stile 15** This is a recently discovered stile in Woodend Lane. It is not on an existing footpath but is fairly close to the start of CCA19 and CCA27 and is shown on the 1953 definitive map as the original starting point of these paths. It is at map reference 744007 (Longitude 51.7046 , Latitude -2.3717 ). It is hidden deep in the hedge and covered with ivy but appears to be in good condition. It has been marked as SS15 on a new post near the roadside.

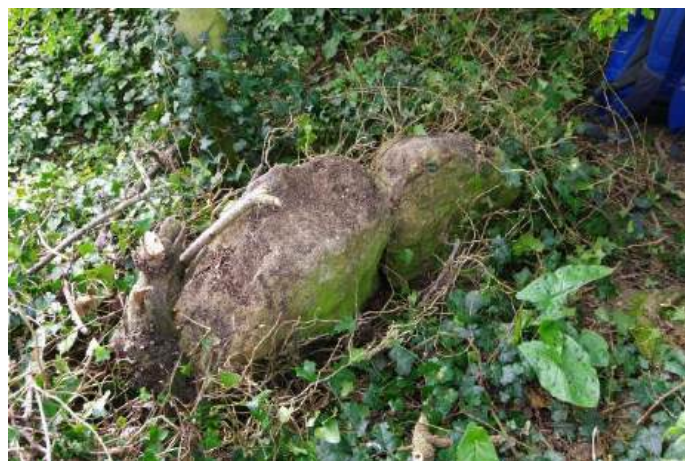
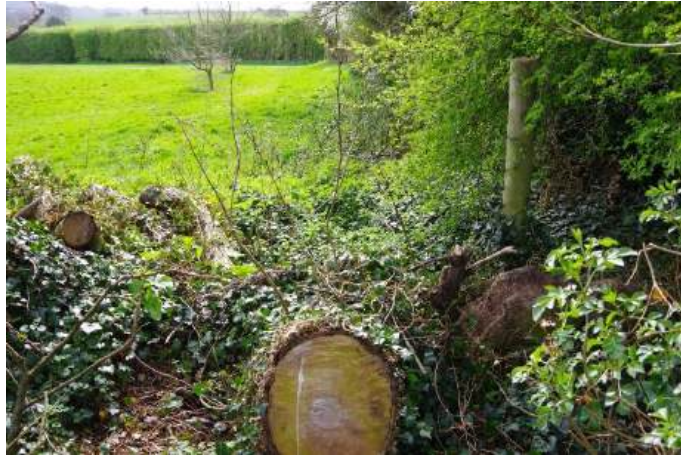
SS16

**Stone Stile 16** This is a recently discovered stile in the Jubilee Field. It is not on an existing footpath but is in an overgrown hedge on a line between an existing stile and the corner of the Jubilee Field nearest to the old Coaley Junction station. It is possible that this path originally went to Coaley Junction but was diverted when part of the field became a local refuse tip. The stone is broken in two but both halves are vertical and look to be in the correct position. It is possible that it was originally built using two stones. The stone is located at 742009 (Latitude 51.7088, Longitude -2.3737). It is next to the remains of a fallen tree and was originally totally covered in ivy. It has been cleared and marked as SS16.
