# **A New Survey of the Stone Stiles of Cam in November 2020 to April 2021**

**By John Fowles**

This new survey was carried out in November 2020 to April 2021 to update and supplement the previous survey. In the meantime an additional stone stile has been found in the Jubilee Field (a Parish Council owned leisure area) and that has been included in this new survey as SS16. Some of the stile numbers have been changed slightly as described in the text.

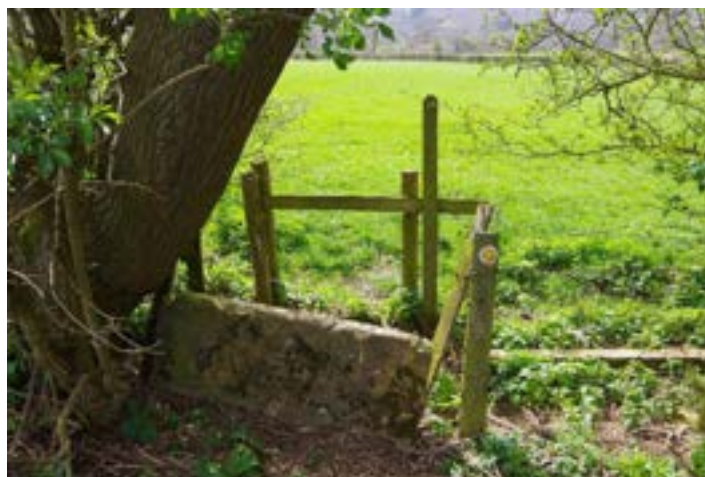
SS1A

**SS1A** is on CCA63 and is in good condition. It is leaning slightly and the adjacent wooden stile has been removed since 2007. It could be raised to the vertical but it is probably not worth the effort. There is a tree leaning across it and the nearby additional wooden stile ( see picture) does not have a step making it difficult to cross (it has a wire mesh within the frame). The 1A marker has been attached to the adjacent post.

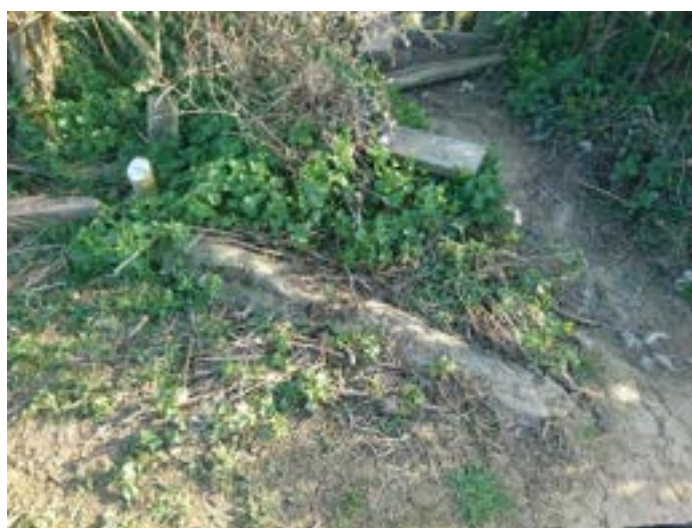
**SS1B** is on CCA60 and is very low. It is probably a complete stile leaning forward and sunk deep into the ground. The accompanying wooden stile has rotted and has been removed to the hedge nearby since 2007. SS1B is worn where walkers used to step onto it after crossing the wooden stile but they can now walk round it. With considerable effort it could be excavated and raised to the vertical. SS1B marker has been attached to a new post close to the hedge.

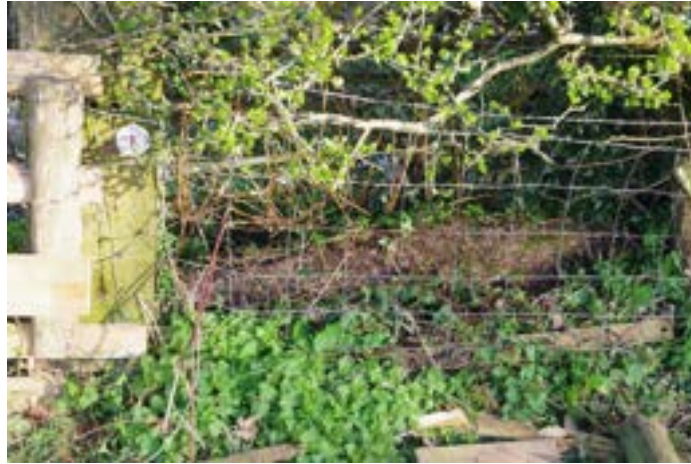
**SS1C** is also on CCA60 by a wooden stile. It is immediately to the west of SS1B. It is deep within the hedge and covered in moss and grass making it difficult to spot. There is also an old iron gate leaning on one side of it. The removal of the grass and other plants to make it more visible would be beneficial. A lot of the ivy has been removed from one side. The SS1C marker has been placed on the wooden post to the left of the picture.

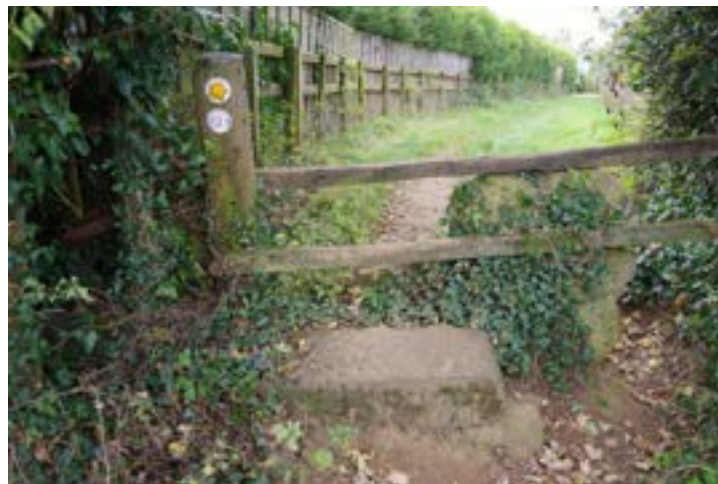
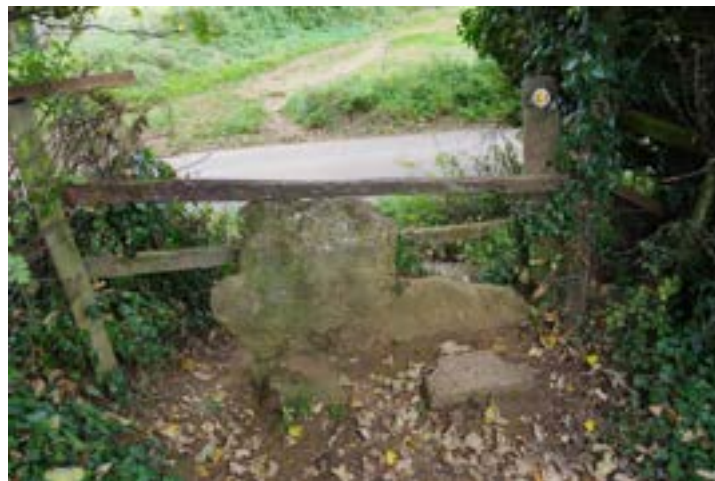
**Stone Stile 2** SS2 is a single stile to the west of Field Lane at the start of paths CCA13 and CCA14 - map reference 738004 (Longitude 51.7016, Latitude -2.3803) near to the mobile phone mast. CCA14 has been diverted by the creation of a large fence and fast-growing, coniferous hedge. The stone is broken but the larger section is upright and supported and protected by the wooden stile. No work is required on this stile. SS2 marker has been attached to the wooden stile.

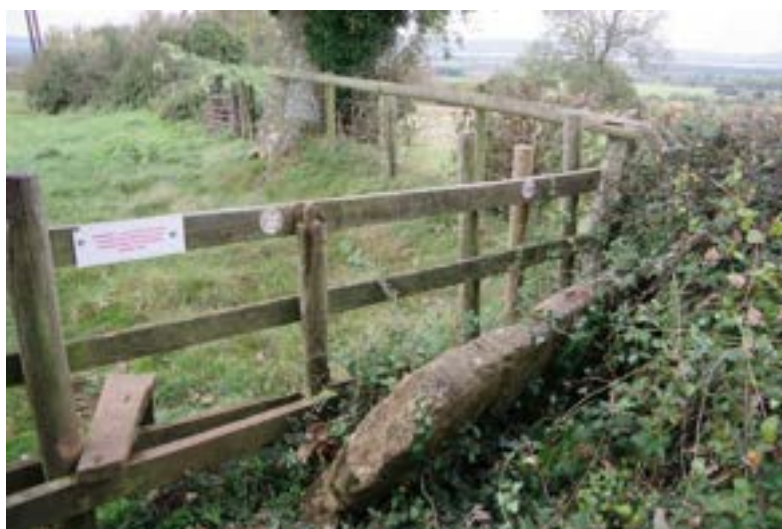
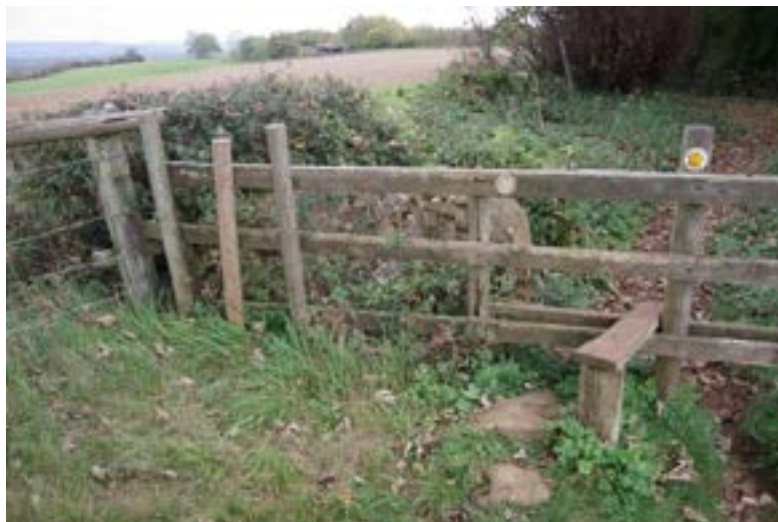
**Stone Stile 3A** SS3A was referred to as SS3 in the 2007 report. It is a single stile beyond an excavated area on CCA13, the same path as SS2. It is at map reference 734004 (Longitude 51.7018, Latitude -2.3833). It is leaning slightly away from the wooden stile and is supported by a small earth bank covered in vegetation which grows across the stone in summer. The stone could be raised to the vertical and supported on the earth bank side by a protective wooden frame. The dense vegetation could be removed from the earth bank making it more visible. SS3A marker has been attached to the wooden stile.

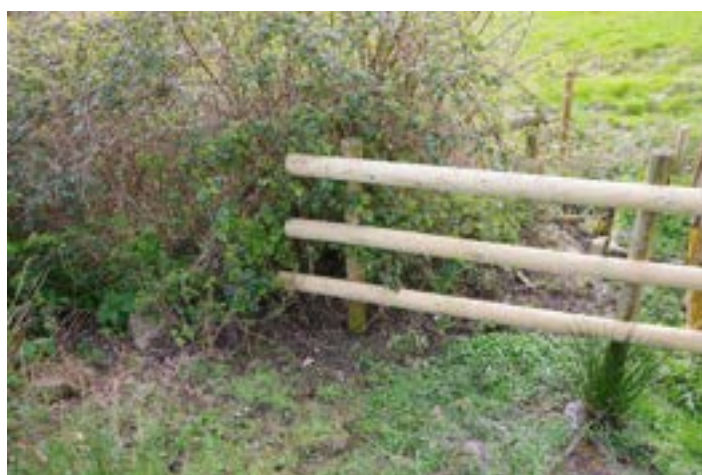
SS3B

**Stone Stile 3B** This was stile 3A in the 2007 report. It is at map reference 734003 (Longitude 51.7011, Latitude -2.3860) next to a spring that fed a trough in 2007. The area is in the same field as SS3A above but in another hedge about a hundred metres to the south and on the route of footpath, CCA107. The bulk of the stone and the trough have been removed since 2007 and a pile of stones at the bottom of the field, next to a gate, is probably it. It was a few metres downhill from a wooden stile but that stile has been replaced by a fence and barbed wire. The area is virtually impassable anyway because the spring that fed the trough now creates a large marshy area and so walkers have had to divert the path to use the gate mentioned above.

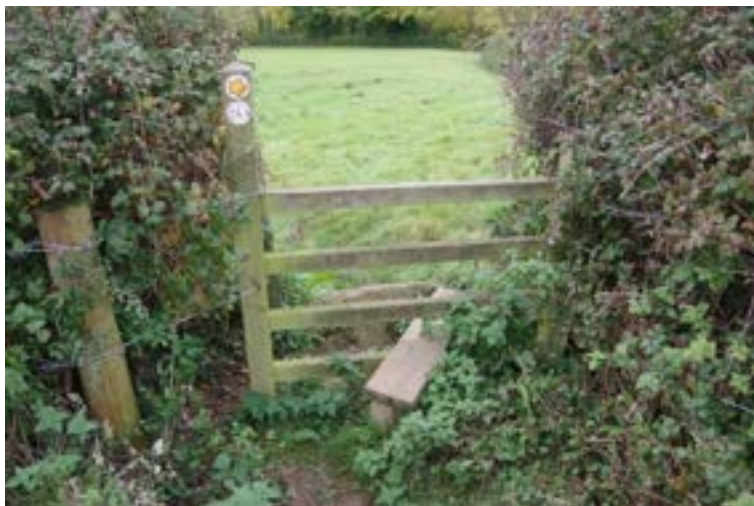
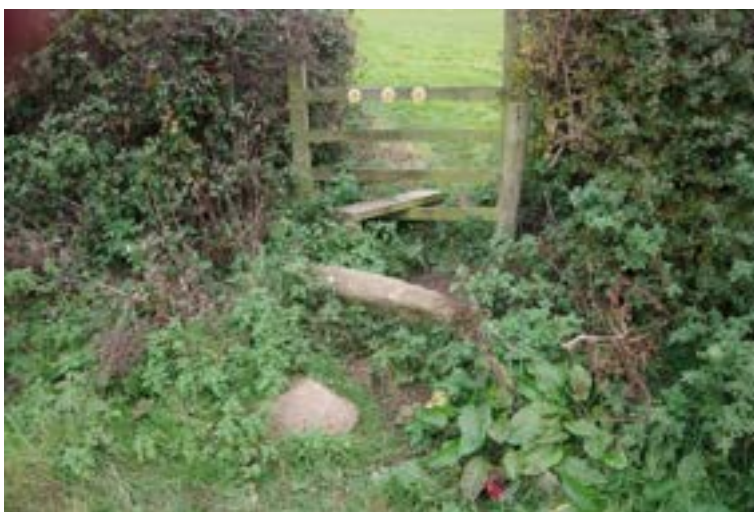
**Stone Stile 4** SS4 is a single stile on CCA13/CCA107 at map reference 733004 (Longitude 51.7016, Latitude -2.3880). It is leaning away from the wooden stile and appears to have a piece broken off and lying nearby. The stone could be raised to vertical, incorporating the broken bit if appropriate, and joined into the wooden stile. This would require considerable effort and the rebuilding of the wooden stile which is in good condition. Marker SS4 has been attached to the wooden stile.

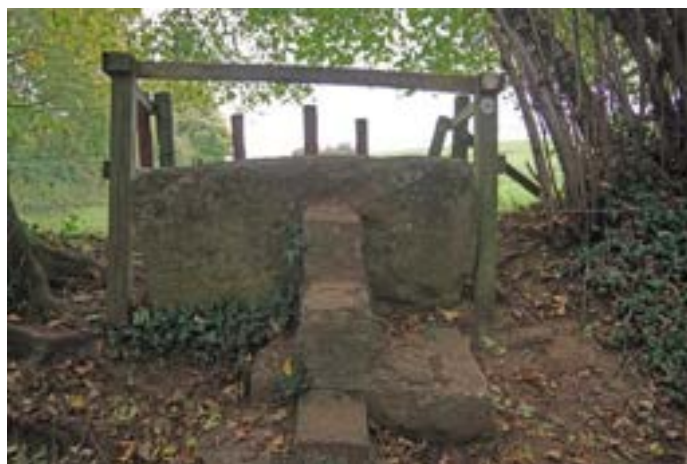
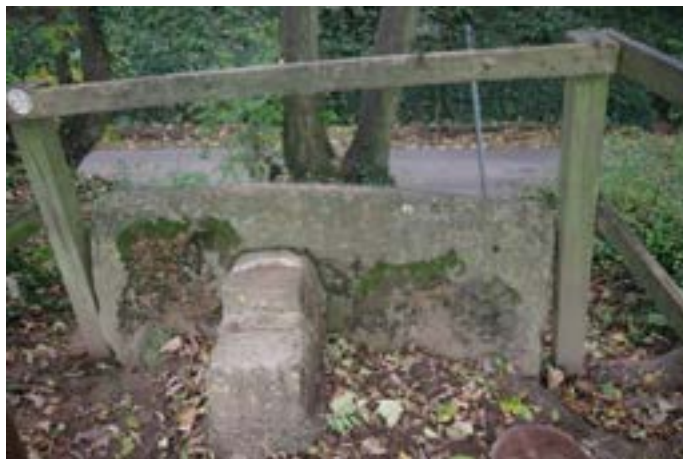
**Stone Stile 5** SS5 is at the top of a bank on the east side of Field Lane on CCA20 at map reference 737007 (Longitude 51.7044, Latitude -2.3209). It is upright, incorporated into a wooden stile and supported on each side by concrete steps. SS5 marker has been attached to the wooden stile.

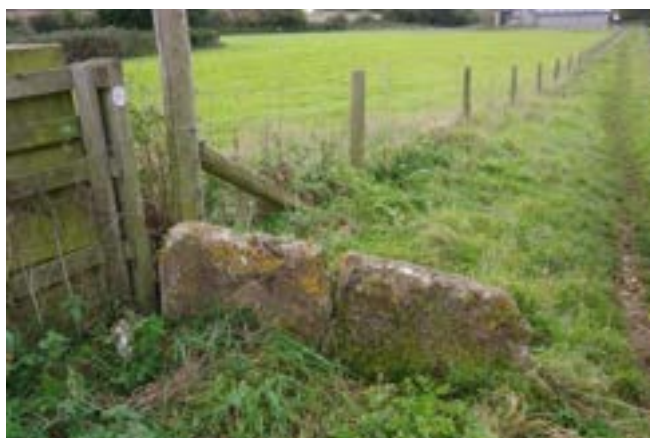
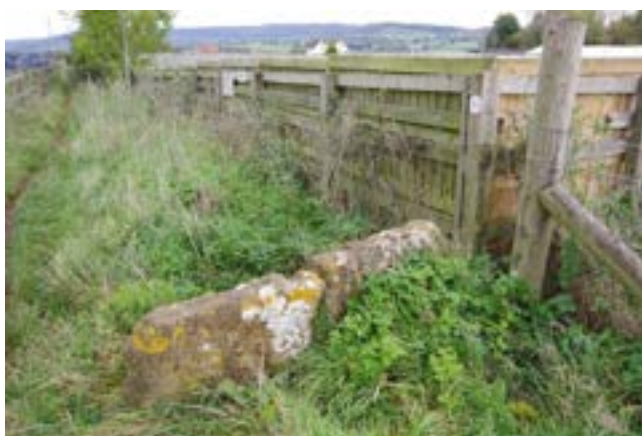
**Stone Stile 6** SS6 is on CCA40, at map reference 740004 (Longitude 51.7023 , Latitude - 2.3771 ). It is broken in two and in 2007 one half was close to horizontal and the other half close to vertical. The horizontal part is now vertical close to its original position. The stone has no supporting frame and the boundary fence/hedge has been removed. SS6 marker has been attached to the fence post.

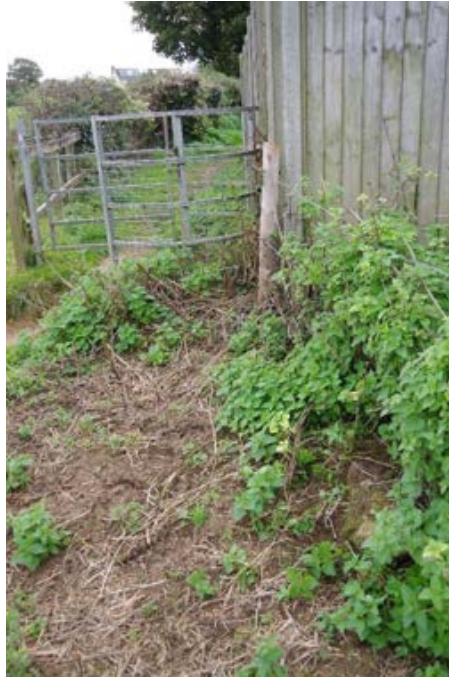
Site of SS7

**Stone Stile 7** This stile on CCA43 at map reference 742004 (Longitude 51.7019 , Latitude -2.3748) was destroyed in 2001 by workmen installing a kissing gate. A small remnant remains in the fence (bottom right of picture).

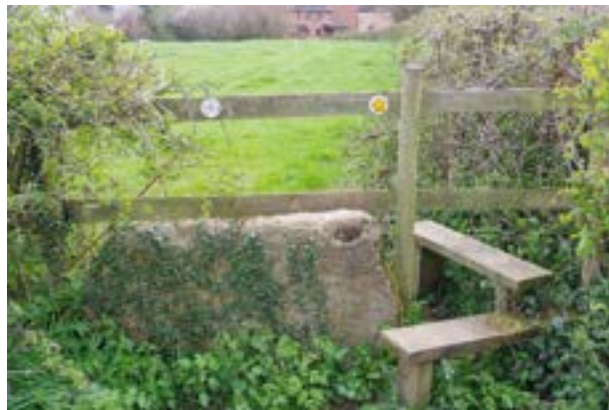
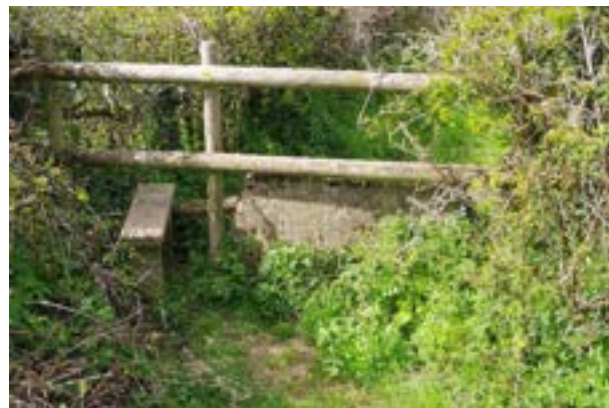
**Stone Stile 8** SS8 is near to the Jubilee Field at Draycott on CCA22 at map reference 745010 (Longitude 51.7074 , Latitude -2.3697). It now vertical within a wooden stile and appears to be complete. It has been marked as SS8 on the wooden stile.

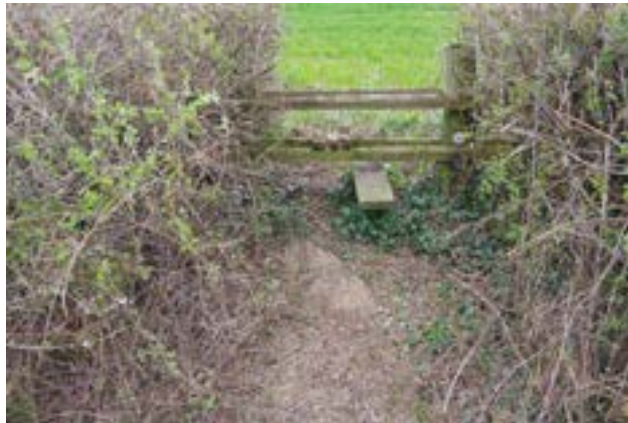
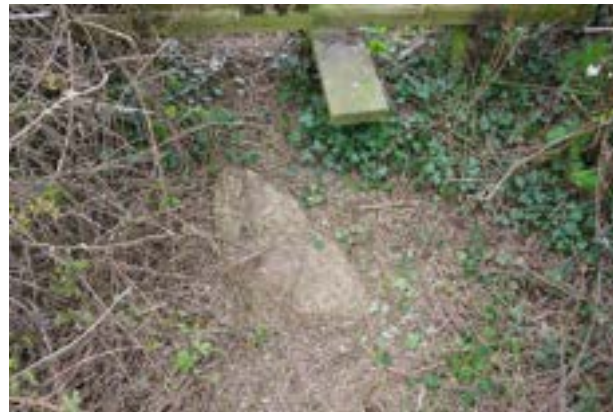
**Stone Stile 9** SS9 is a fragment of what could have been a stone stile lying next to a wooden stile on CCA24 at map reference 744015 (Longitude 51.7116 , Latitude -2.3707). It is

not obvious how it relates to an original stone stile. It is currently used as a stepping stone but could be secured within the existing wooden stile to protect it. It has been marked as SS9. This stile was heavily covered with brambles and hawthorn and that has now been removed to make the stile usable again. The SS9 marker has been attached to the wooden stile.

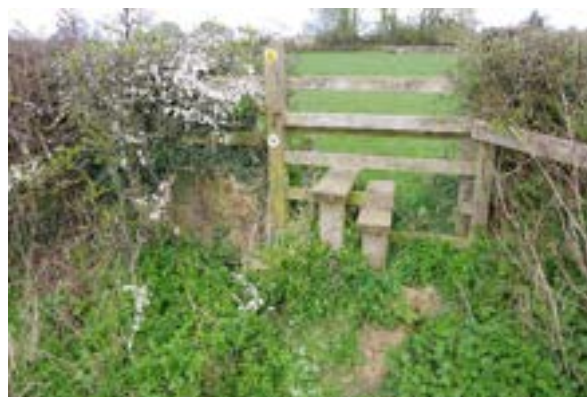
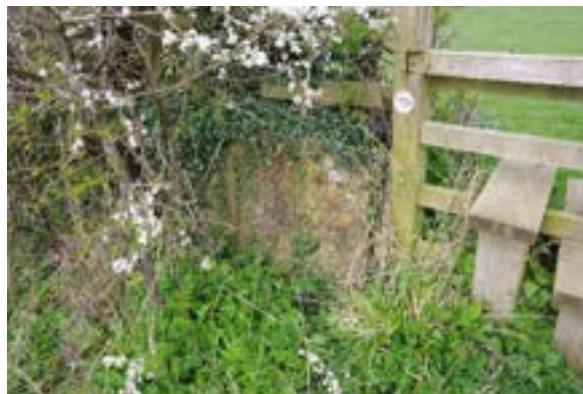
**Stone Stile 10** SS10 is close to SS9 on CCA24 at map reference 745015 (Longitude 51.7126 , Latitude -2.3693). It stands in the hedgerow next to a wooden stile and is close to vertical. The hedge could be cut back on one side to make it more visible. The SS10 marker has been attached to the wooden stile.

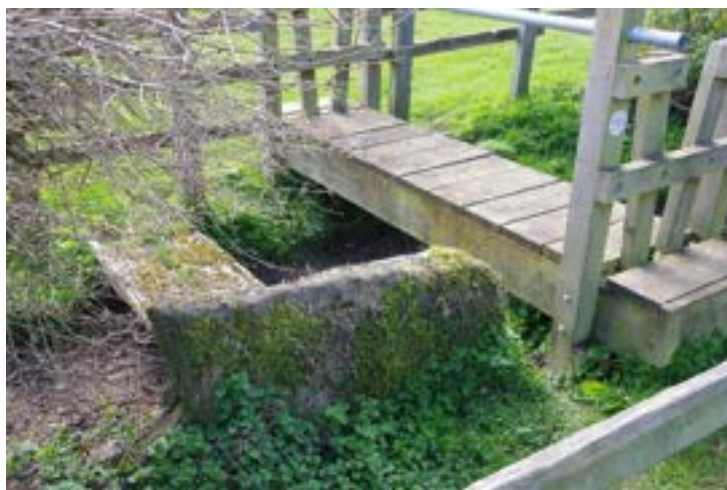
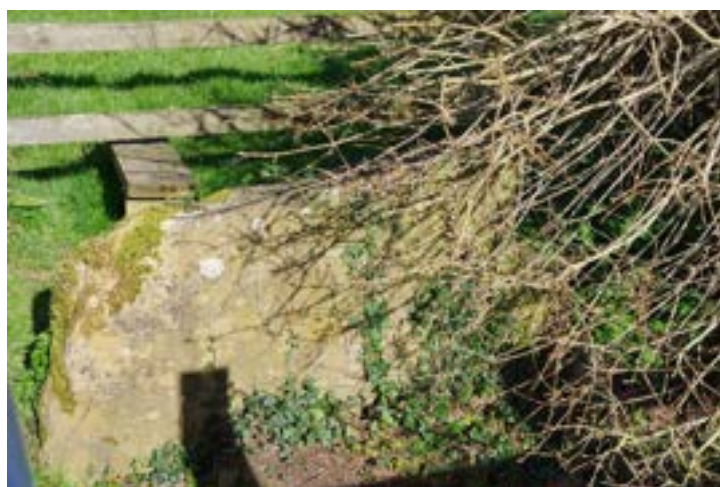
**Stone Stile 11** SS11 is in the same footpath as SS9 and SS10, CCA24, at map reference 746016 (Longitude 51.7130 , Latitude -2.3683). It stands vertically and requires no work doing to it. A new stile and bridge has been built next to it, bypassing the original stile and bridge over the ditch. It has been marked SS11 on the new stile.

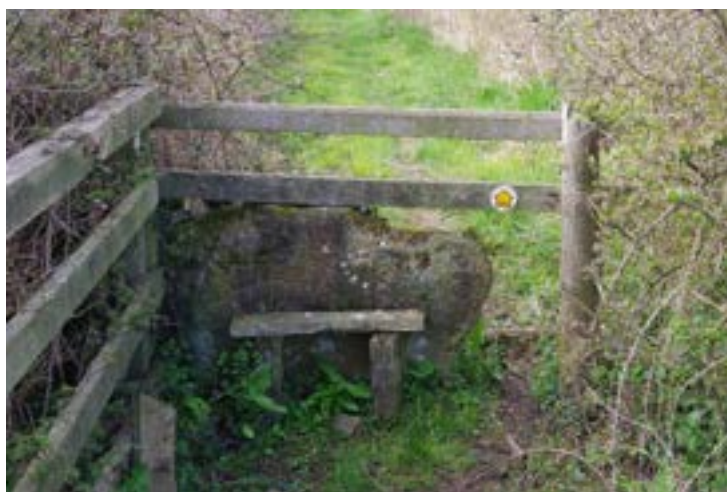
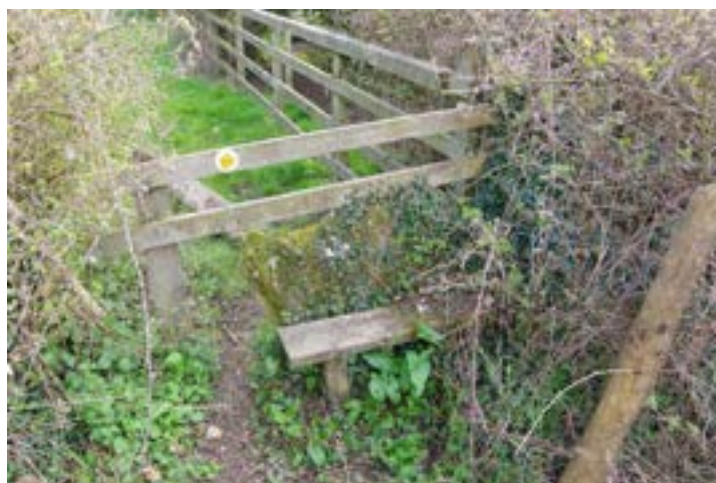
**Stone Stile 12** SS12 is just around the corner from SS11, but on CCA25, and at the same map reference 746016 (Longitude 51.7131 , Latitude -2.3682). It looks damaged but is vertical and well supported in a wooden stile. No work is required on it. It has been marked SS12.

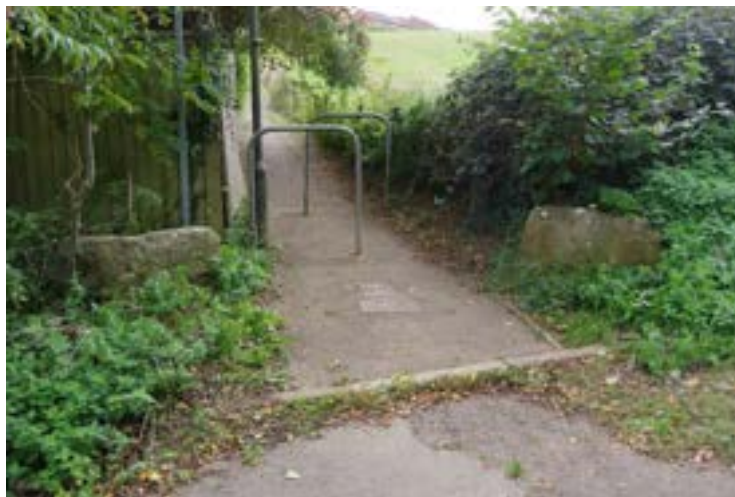
**Stone Stile 13** SS13 is the junction of Blind Lane, Elstub Lane and a footpath to Woodfield, CCA50. It is on the edge of the Bovis Estate at map reference 745002 (Longitude 51.7131 , Latitude -2.3682 ). The stone is in two halves and they have been positioned on either side of the start of the footpath to Woodfield. I am told that it was originally at a field boundary higher up this footpath (nearer to Woodfield). Given that the footpath has been converted to a 'snicket' or urban alley it is not clear how the stile could be replaced. It is probably best left where it is. It has been marked as SS13 on a new post.

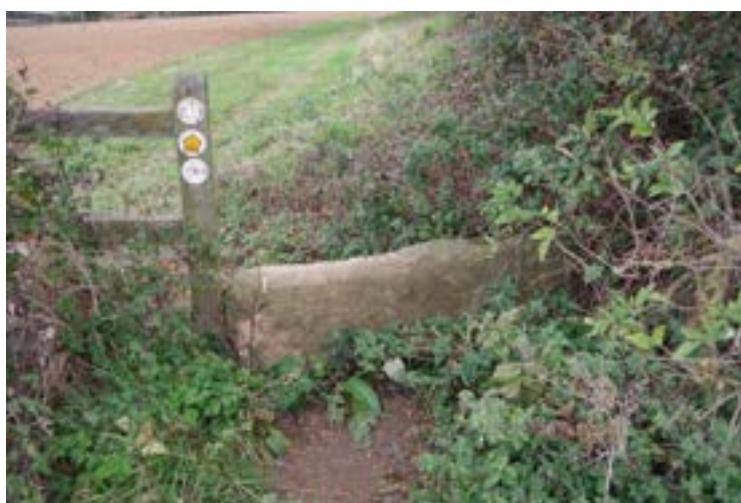
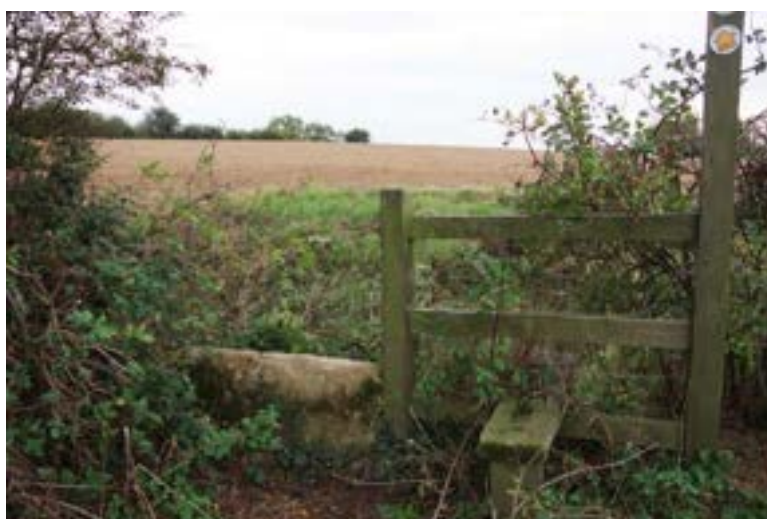
**Stone Stile 14** SS14 is on the path between SS4 and SS5, CCA12. It stands next to a wooden stile at map reference 735005 (Longitude 51.7031, Latitude -2.3849). It is close to vertical and the brambles have been removed. It is now used by walkers instead of the wooden stile. SS14 marker has been attached to the wooden stile.

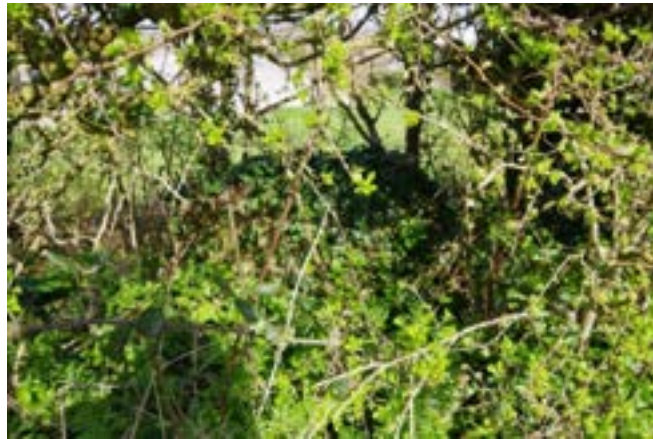
**Stone Stile 15** This is a recently discovered stile in Woodend Lane. It is not on an existing footpath but is fairly close to the start of CCA19 and CCA27 and is shown on the 1953 definitive map as the original starting point of these paths. It is at map reference 744007 (Longitude 51.7046 , Latitude -2.3717 ). It is hidden deep in the hedge and covered with ivy but appears to be in good condition. It has been marked as SS15 on a new post near the roadside.

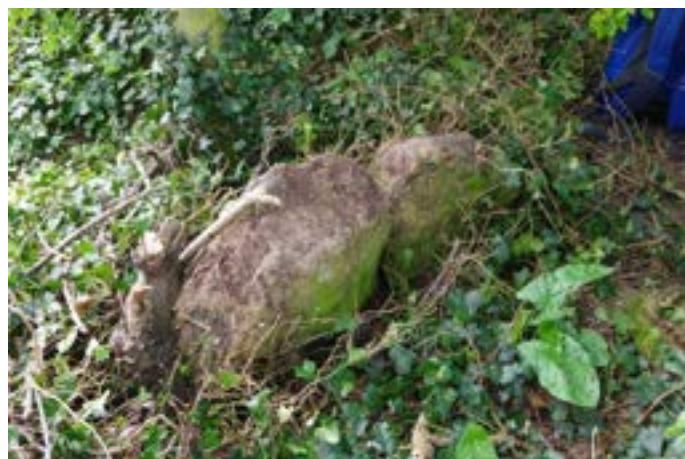
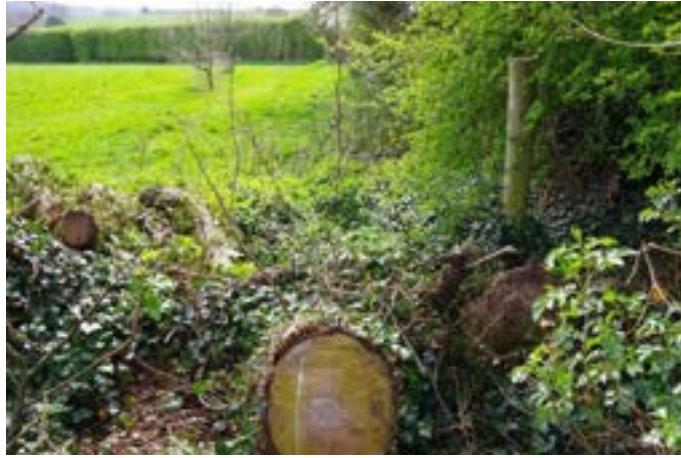
SS16

**Stone Stile 16** This is a recently discovered stile in the Jubilee Field. It is not on an existing footpath but is in an overgrown hedge on a line between an existing stile and the corner of the Jubilee Field nearest to the old Coaley Junction station. It is possible that this path originally went to Coaley Junction but was diverted when part of the field became a local refuse tip. The stone is broken in two but both halves are vertical and look to be in the correct position. It is possible that it was originally built using two stones. The stone is located at 742009 (Latitude 51.7088, Longitude -2.3737). It is next to the remains of a fallen tree and was originally totally covered in ivy. It has been cleared and marked as SS16.
